DATA I/O Corporation

Subject: PnP (SMAC) Head Tuning Guide

Service Bulletin – 147B

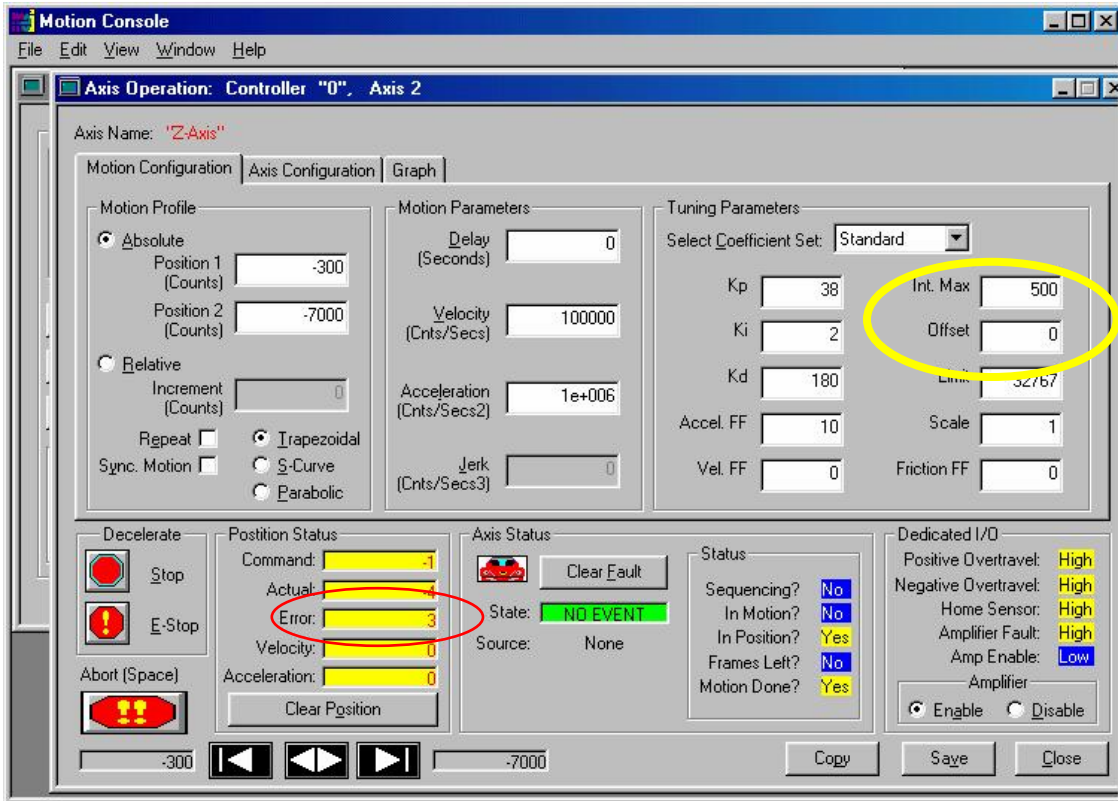
Within “Motion Configuration” tab note the value for “Int. Max”, “Offset” and “Error”. Here, the error is -3 when Offset is 0 (zero)

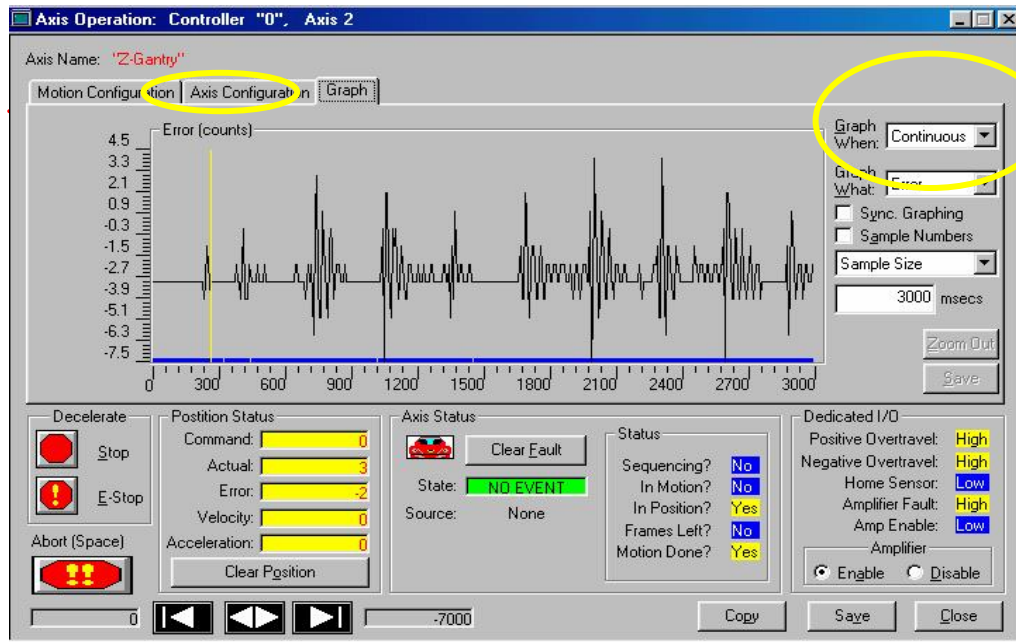
Switch to “Graph” tab, click on the drop down arrow for “Graph When” and select “Continuous” from the options. Similarly, for “Graph What” select “Error”. Observe the “Error (counts)”

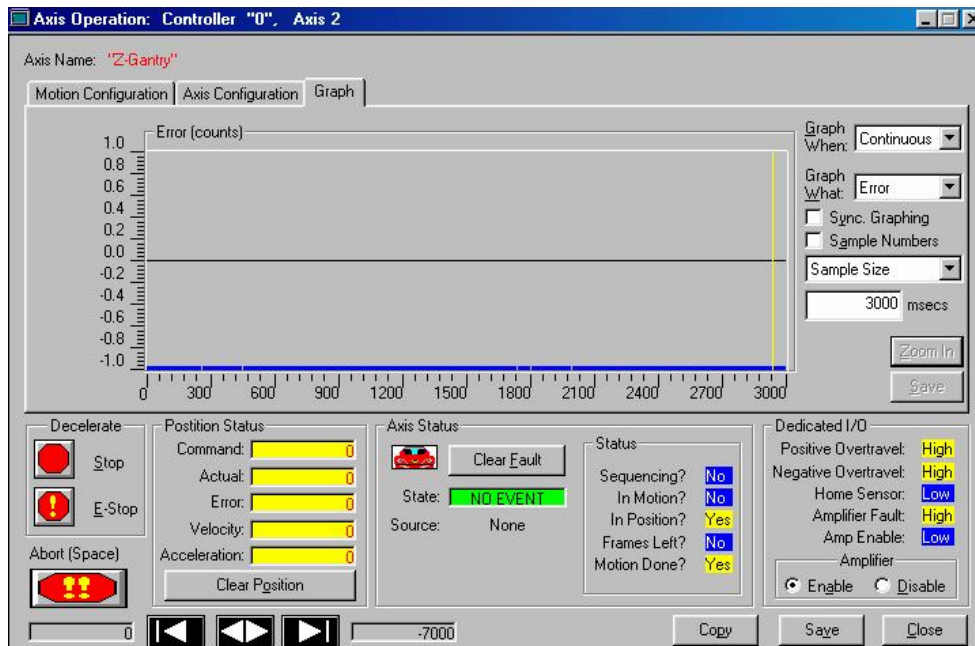
After changing the “Offset” and “Int Limit” observe the “Error (counts)” on the Graph screen. Ideally, there should be no error – zero error, like below. If error is not close to zero, try different values for “Offset”
