DATA I/O Corporation

Subject: PnP (SMAC) Head Tuning Guide

Service Bulletin – 147B

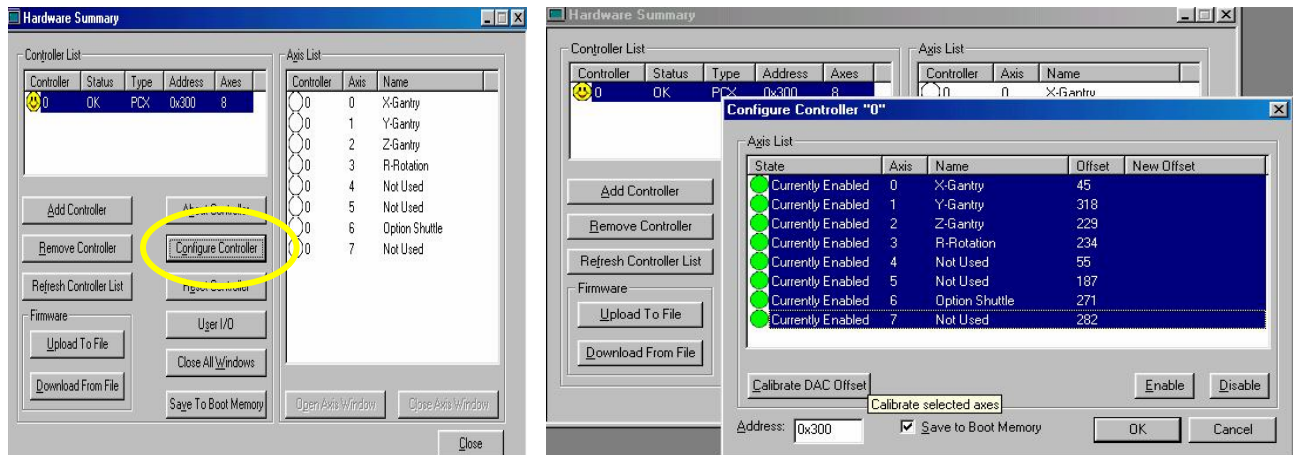
Click on “Configure Controller”, select all axes, check the box labeled “Save to Boot Memory” and then click on “Calibrate DAC Offset” button

First “configure” the MEI card. This will test the MEI card, configure its internal DAC offsets and re-load the motion parameters from motion parameter file.

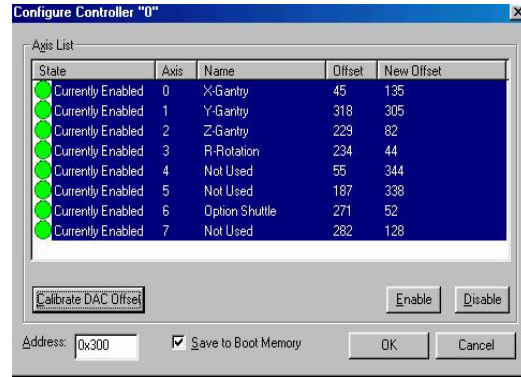
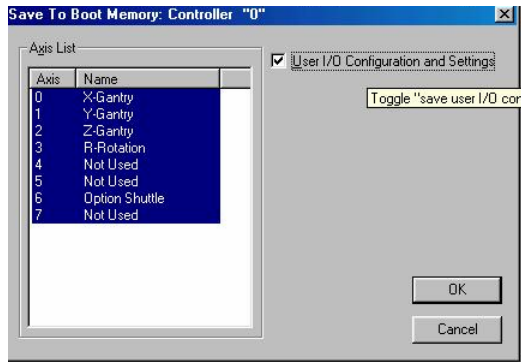
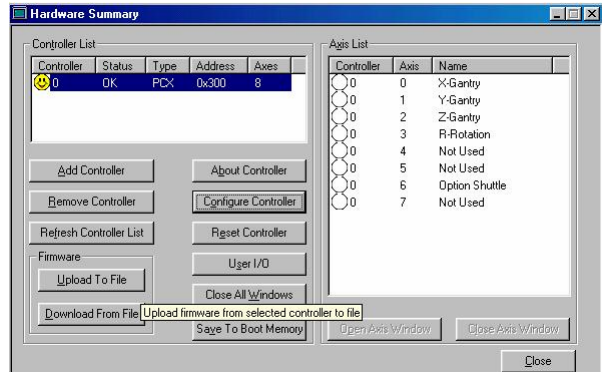
- Save values to Boot Memory, ensuring “User I/O Configuration and Settings” box is checked.
- Save parameters to file, by clicking on “Upload To File” button, which will upload firmware from controller’s memory into a parameter file.

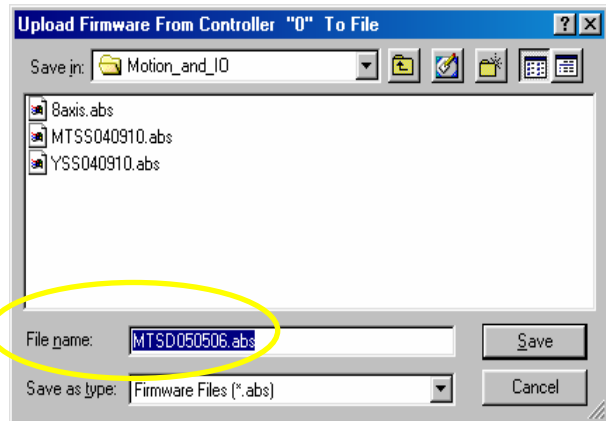
Here file is: MTSD050506.abs

After Saving the file, delete the file 8Axis.abs and then Copy this new file and rename the copied version to 8Axis.abs

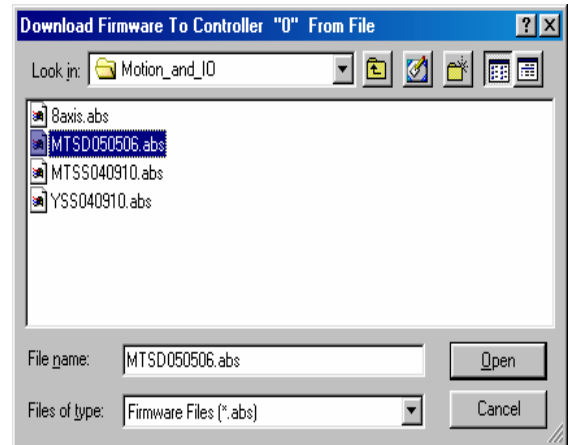
Click on the button “Download From File”
IN the dialog window select the required file, here
the selected file is MTSD050506.abs
And click on Open.

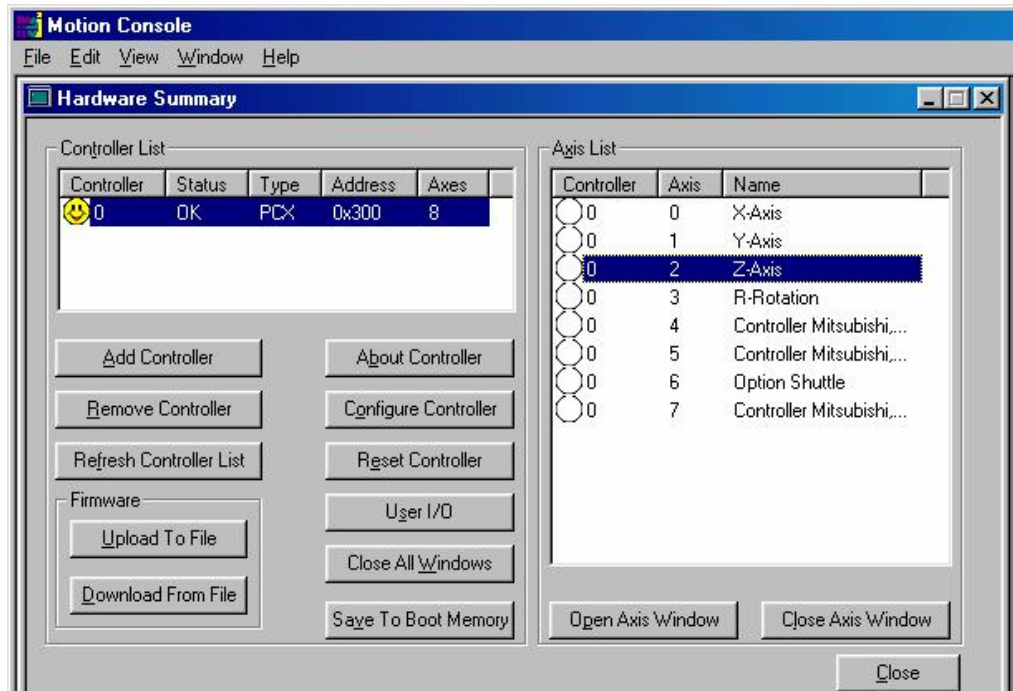
On Handler computer, navigate to “C:\Install\MEI and Autopak\” directory and invoke the MC_DSP_95.EXE Motion Console program.

Select Axis-2, which is the Z-Axis
